## Commercial Site Survey

Property Address:  
**3340 W. Southern Ave**  
**Phoenix, AZ 85041**

Inspected on Fri, Sep 28 2012 at 12:25 PM

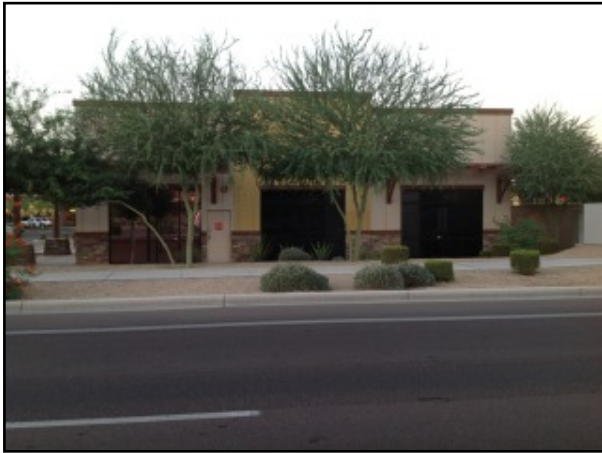
Figure 1-1

Comment 1:  
Front.

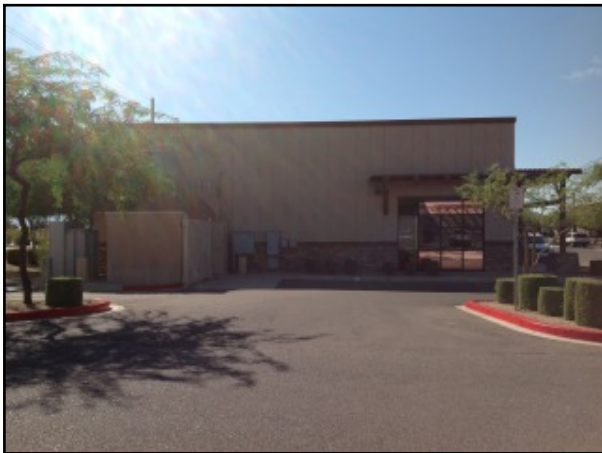
Figure 2-1

Comment 2:  
Right.

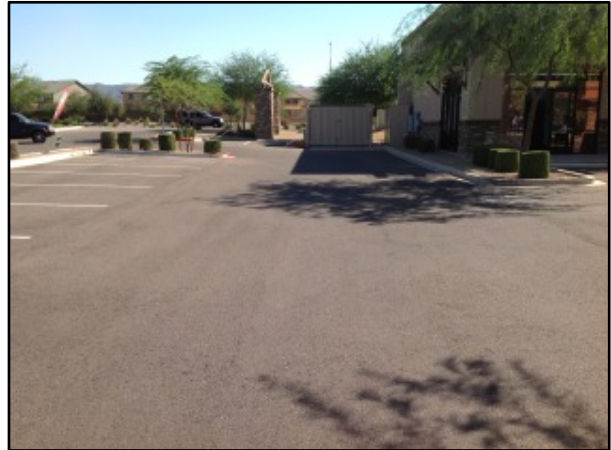
Figure 5-2

Comment 5:  
Right.

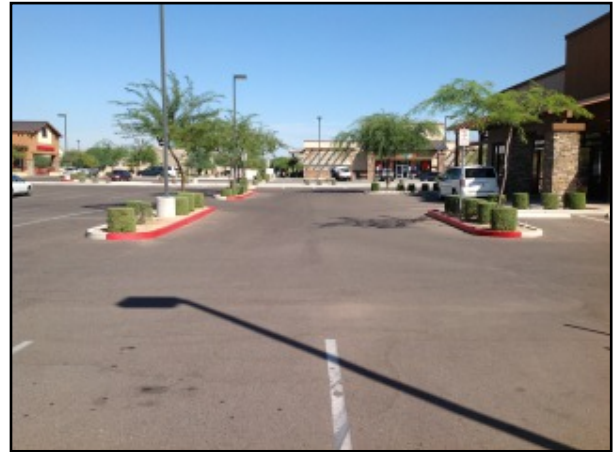
Figure 6-2

Comment 6:  
Rear.

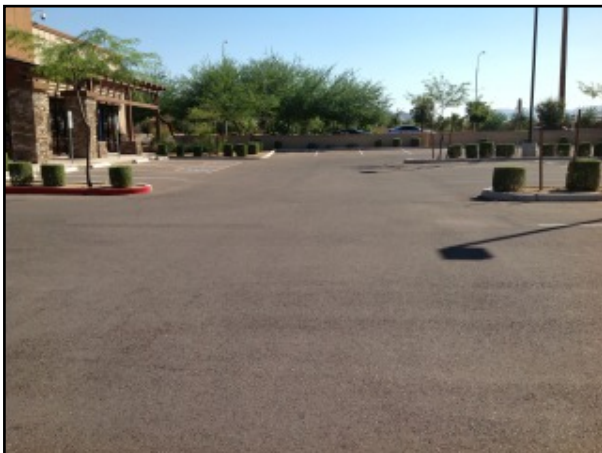
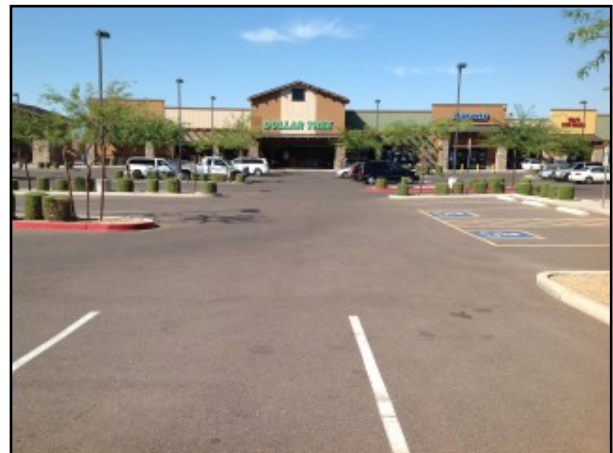
Comment 7:  
Left.

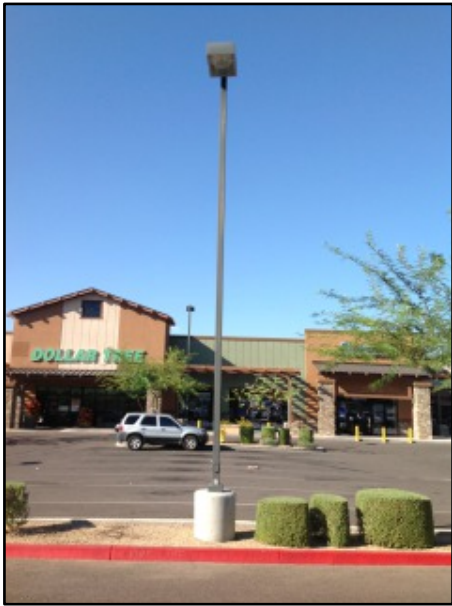
Figure 8-1

Comment 8:  
Pole light.

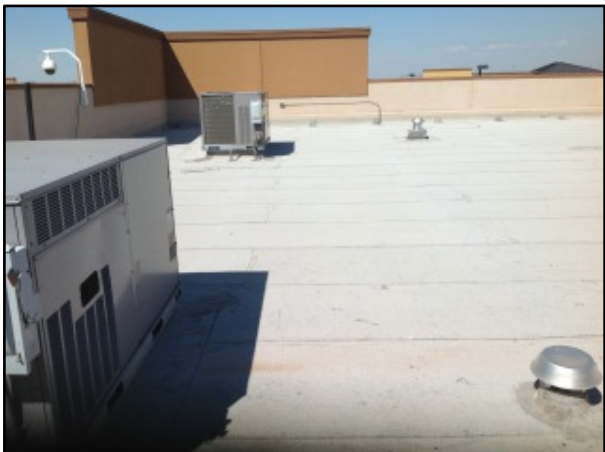
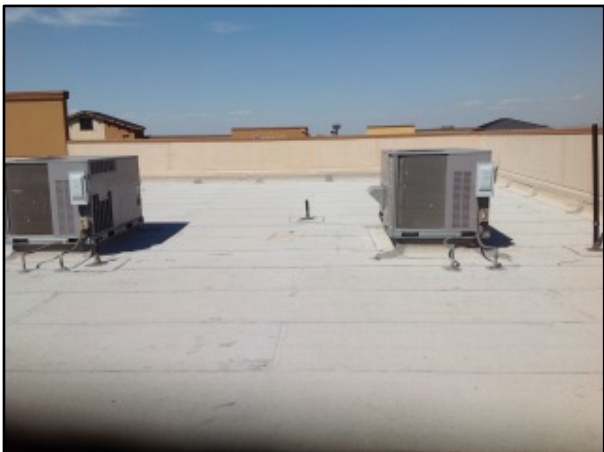
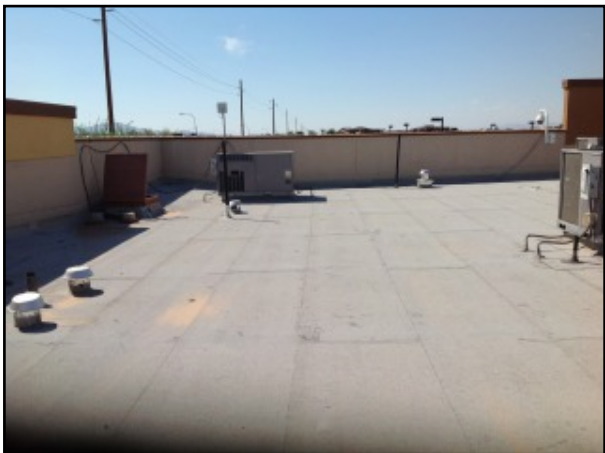
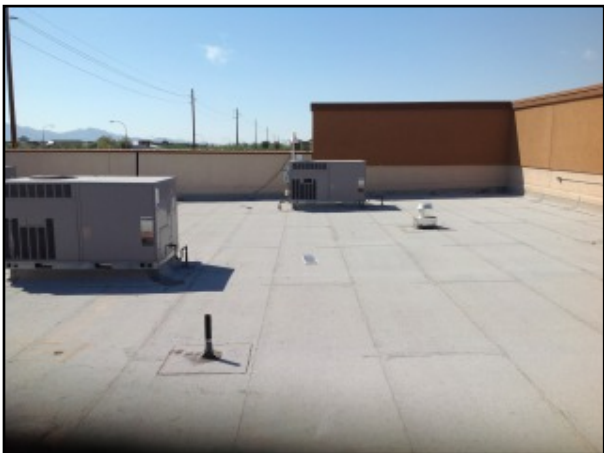
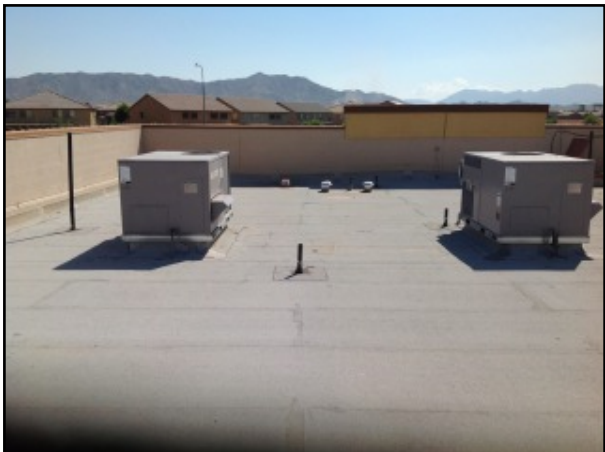
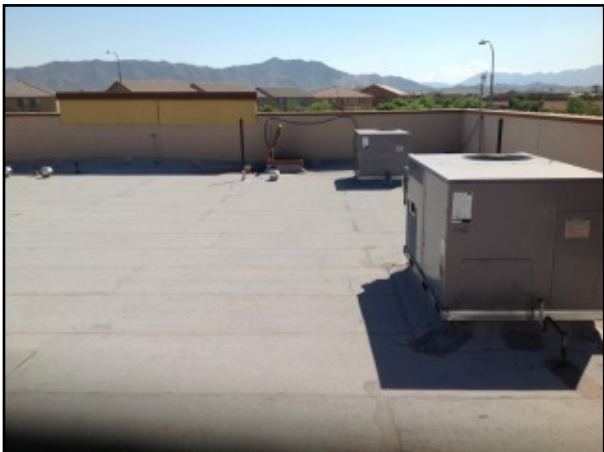
Comment 9:  
Rooftop.

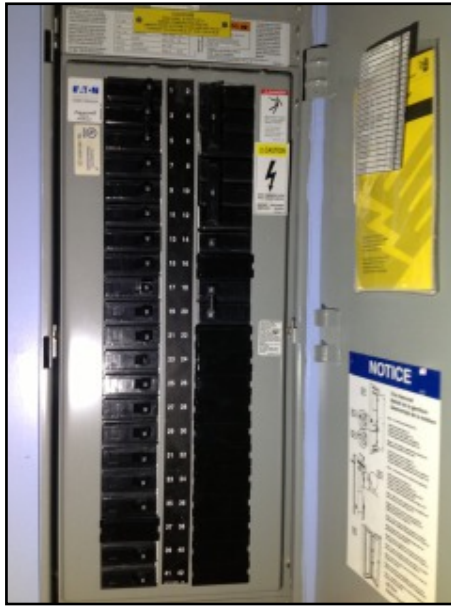
Figure 25-1

Comment 25:  
Sub.

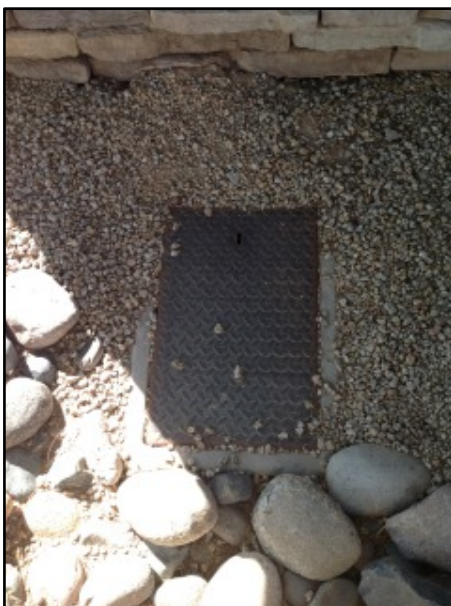
Figure 46-1

Comment 46:  
Meter.

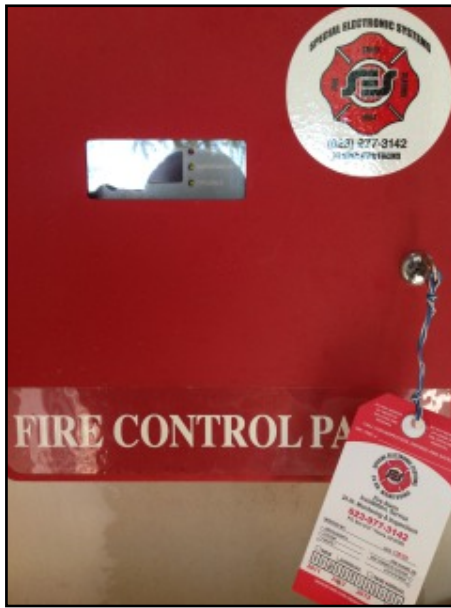
Figure 48-1

Comment 48:  
Fire control panel.

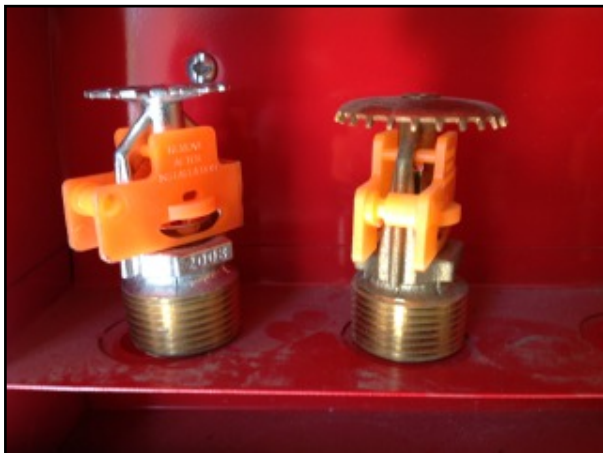
Figure 49-1

Comment 49:  
Sprinkler head types.
