## Commercial Site Survey

Property Address:  
**3340 W. Southern Ave**  
**Phoenix, AZ 85041**

Inspected on Fri, Sep 28 2012 at 12:25 PM

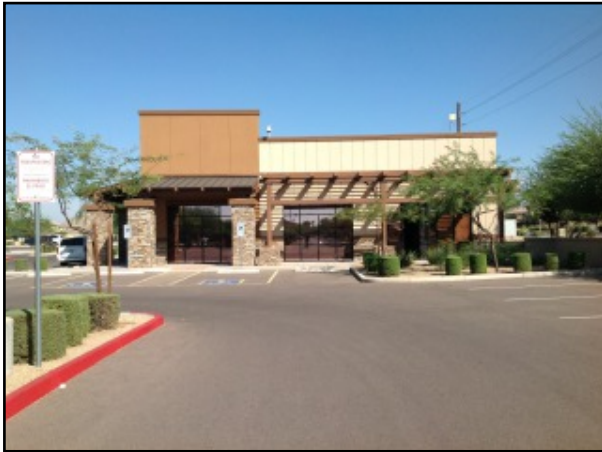
Figure 3-1

Comment 3:  
Left.

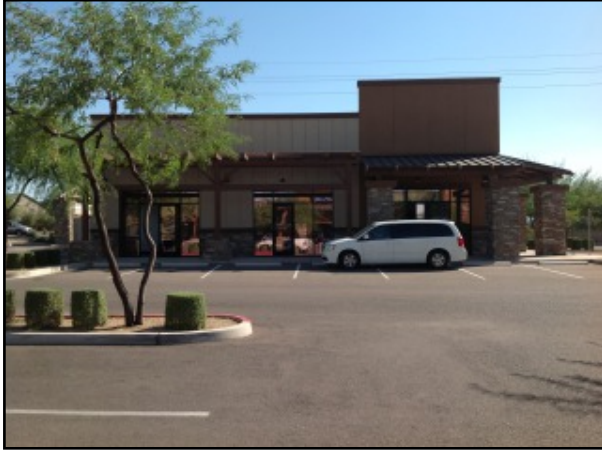
Figure 4-1

Comment 4:  
Rear.

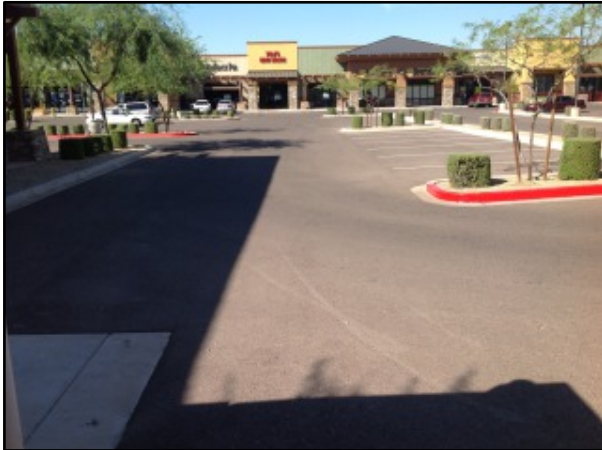
Figure 5-1

Comment 5:  
Right.

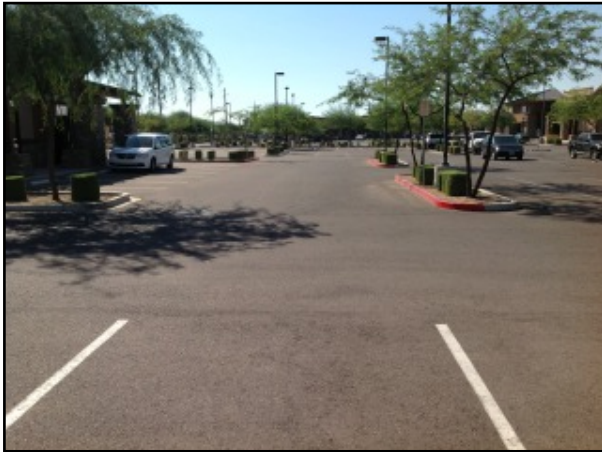
Figure 6-1

Comment 6:  
Rear.

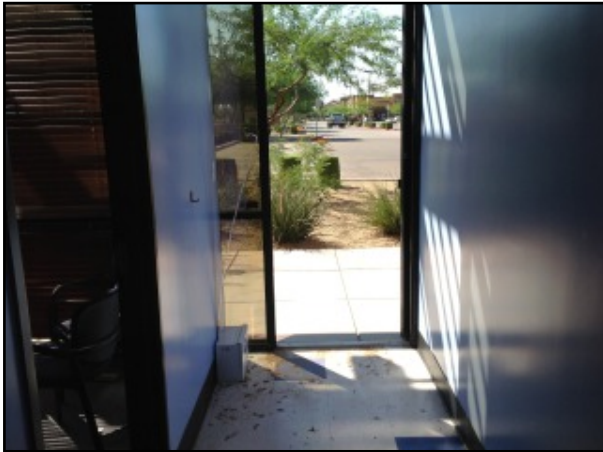
Comment 11:  
Left Hall.

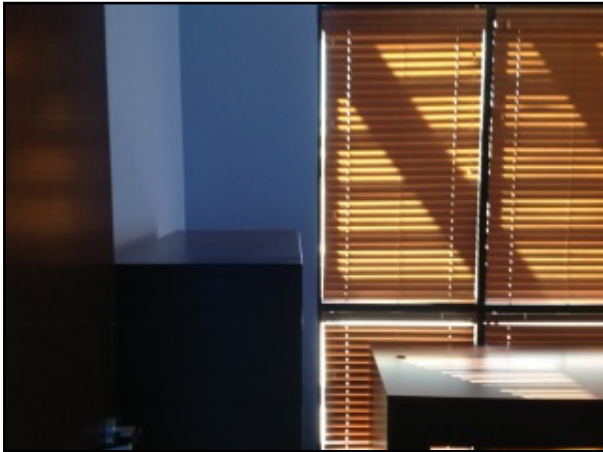
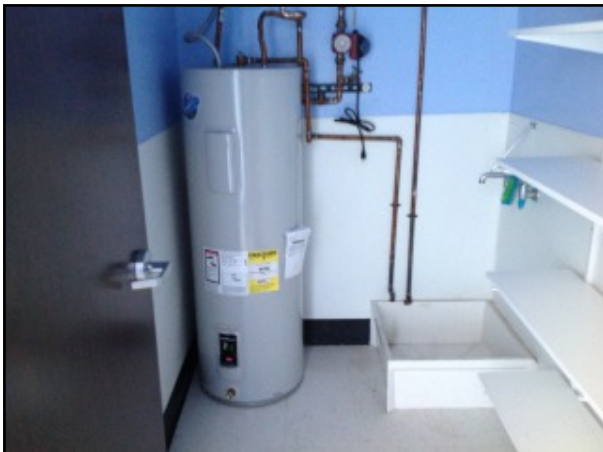
Comment 12:  
Offices left.

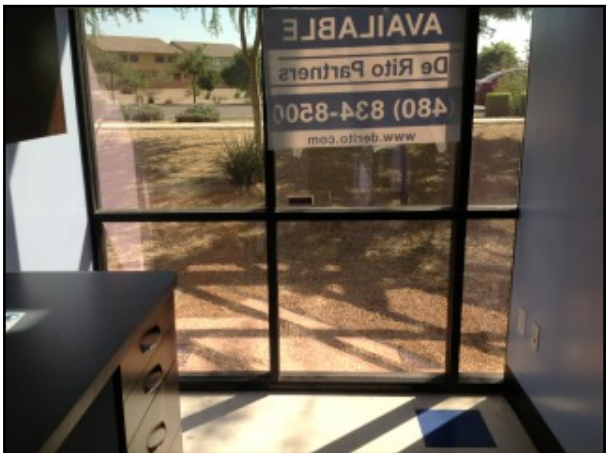
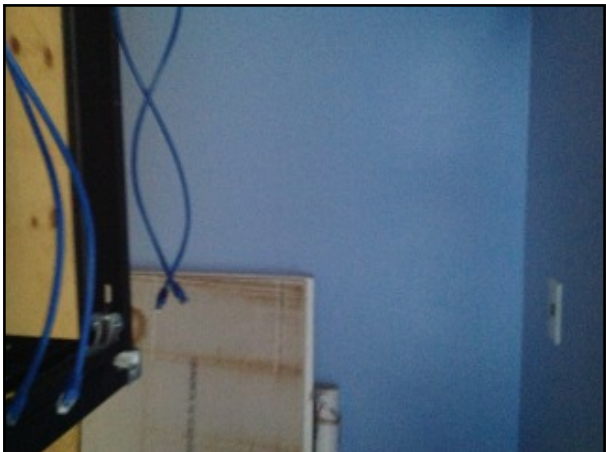
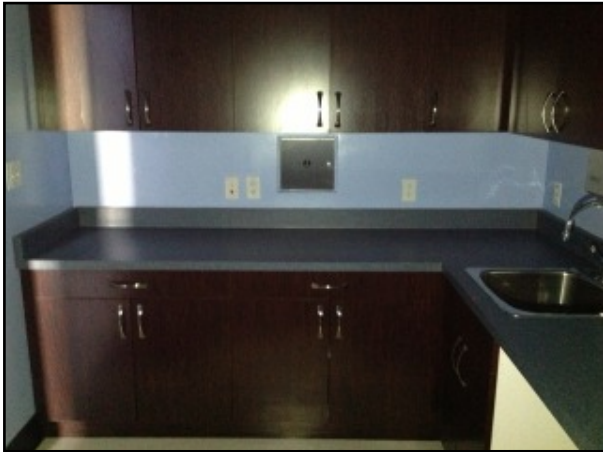
Comment 13:  
Back lab-rooms.

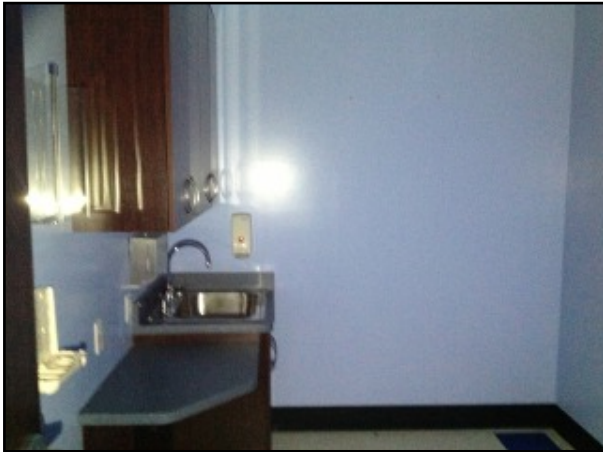
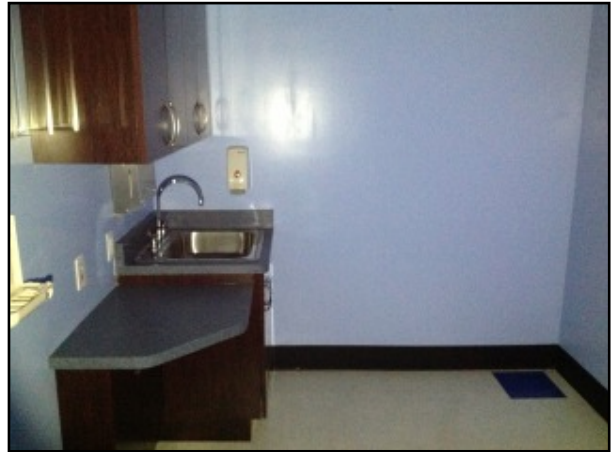
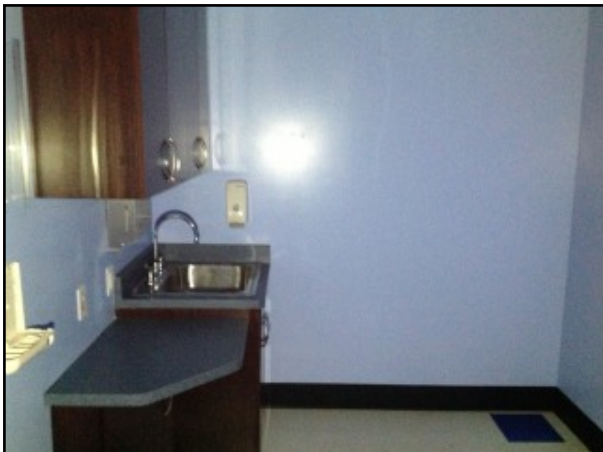
Comment 14:  
Middle left rooms.

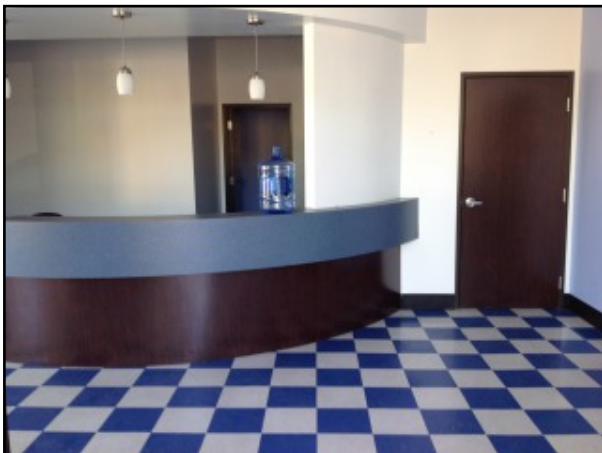
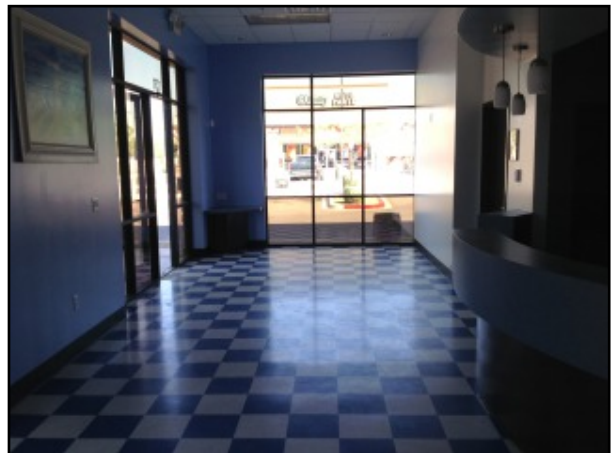
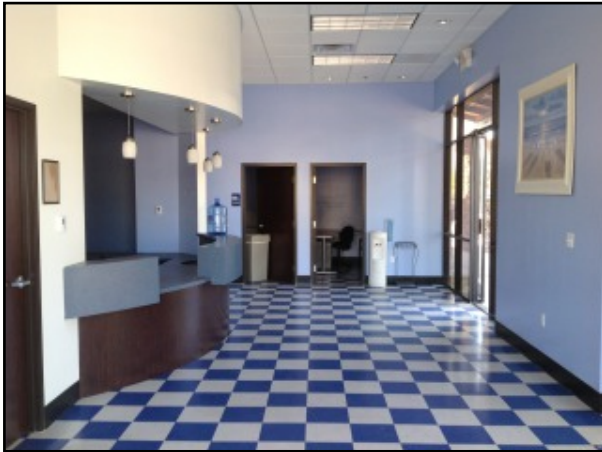
Comment 15:  
Waiting room area.

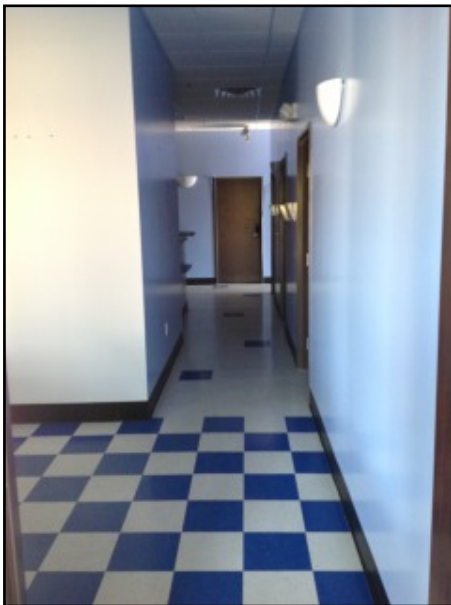
Comment 16:  
Mid and right halls.

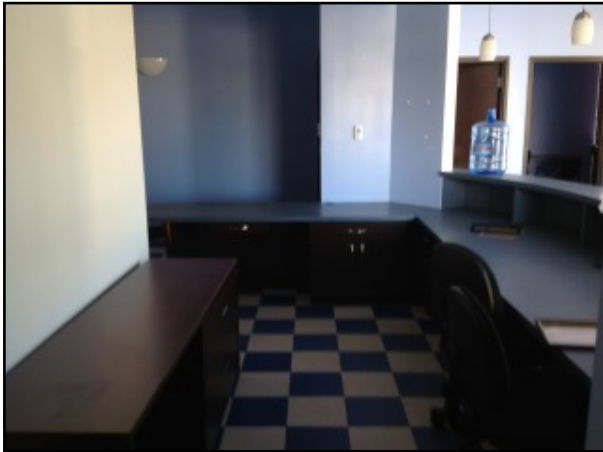
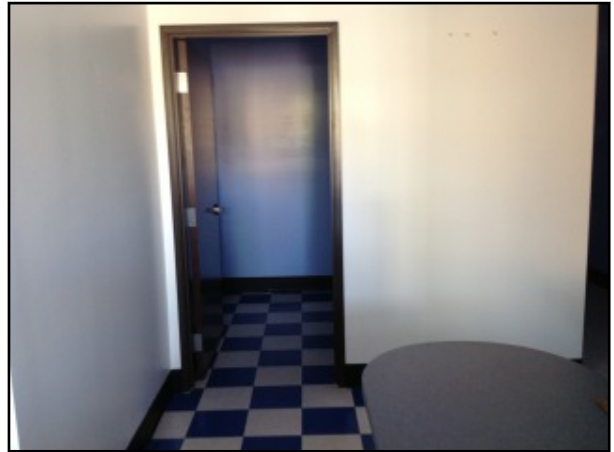
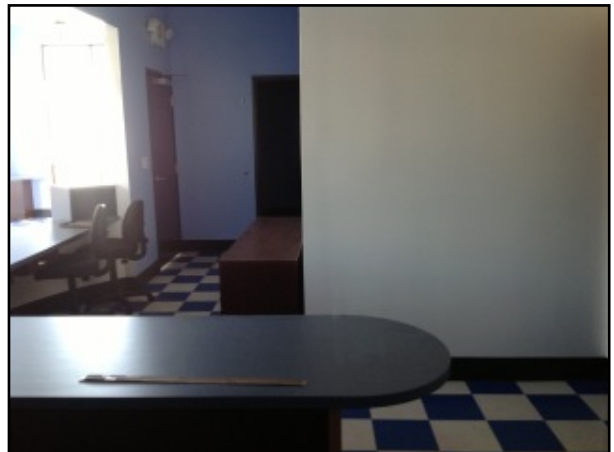
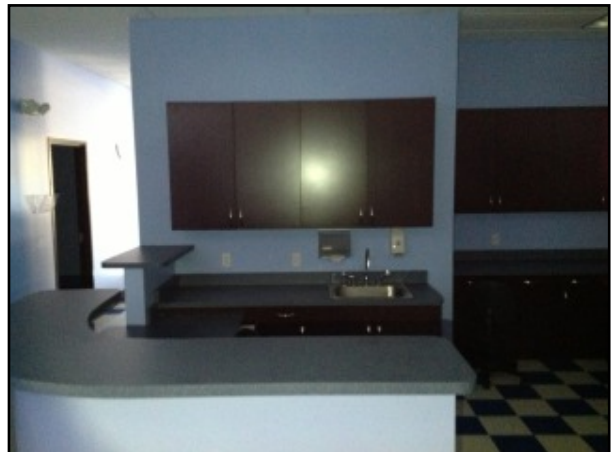
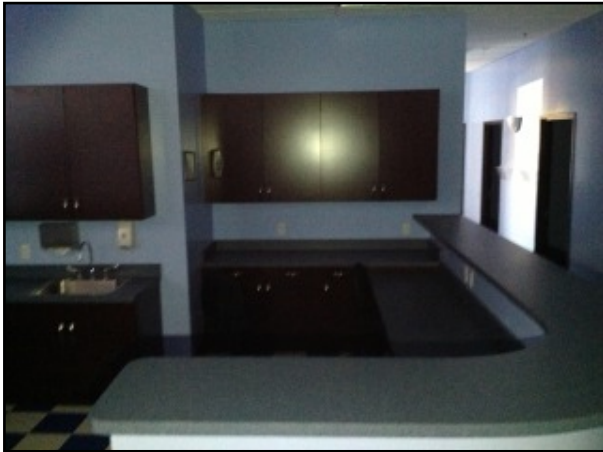
Comment 17:  
Mid reception and rooms.

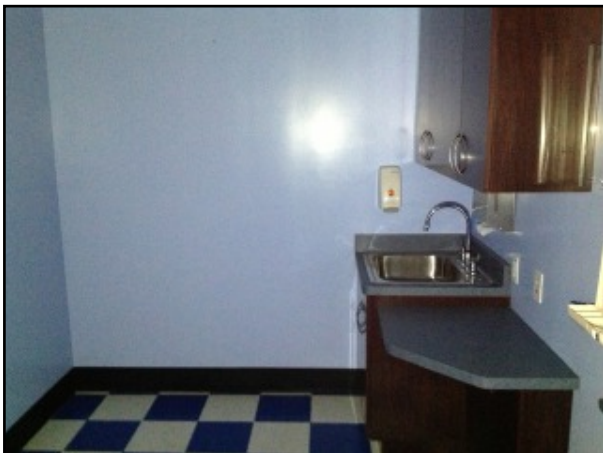
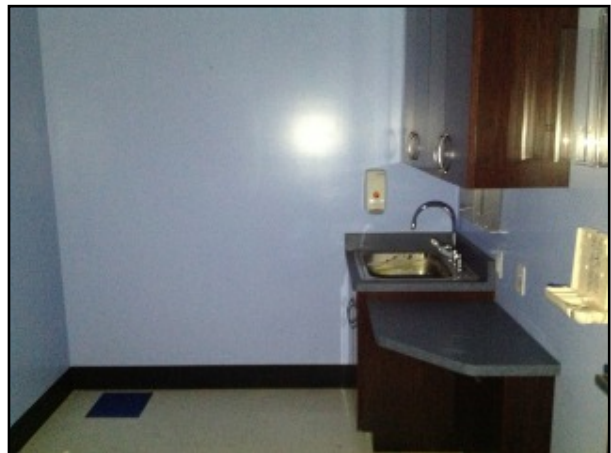
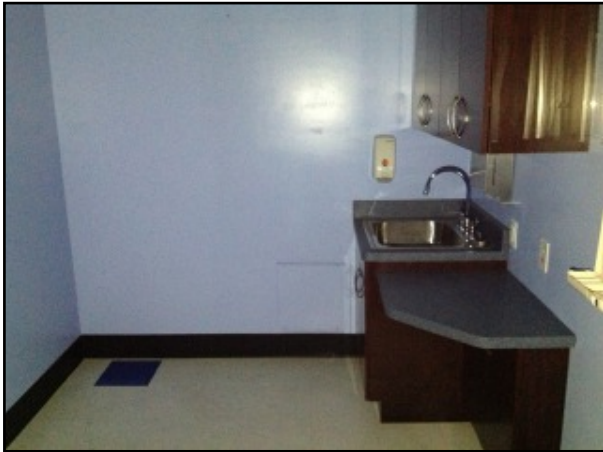
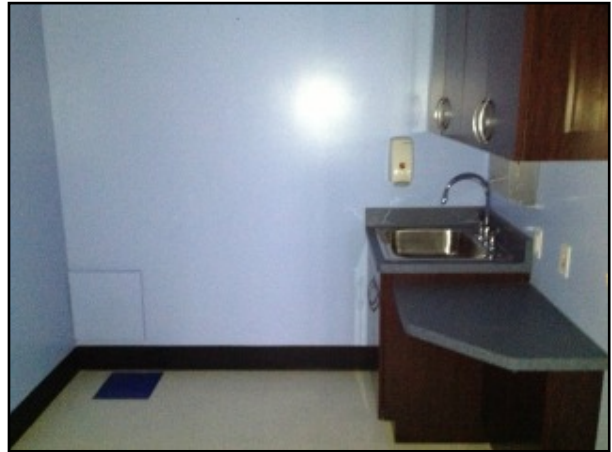
Comment 18:  
Right Rooms.

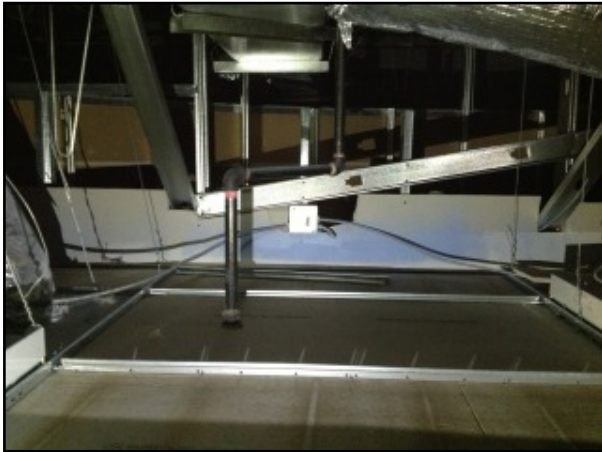
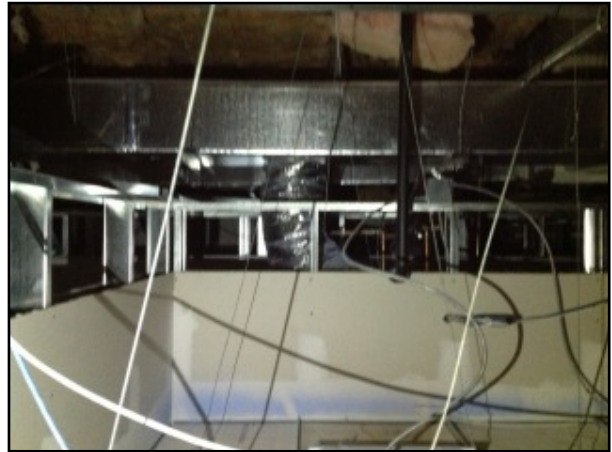
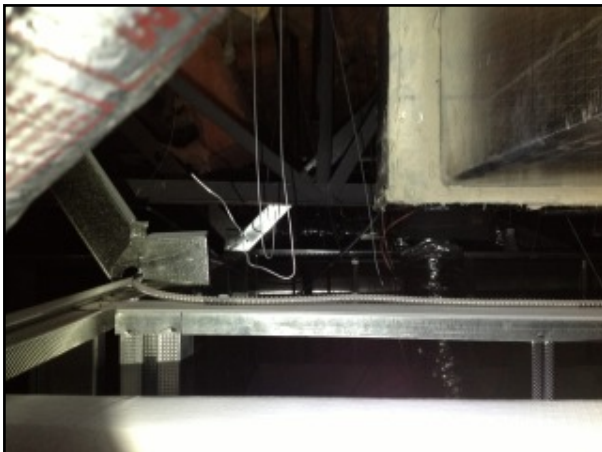
Comment 20:  
Above ceiling.

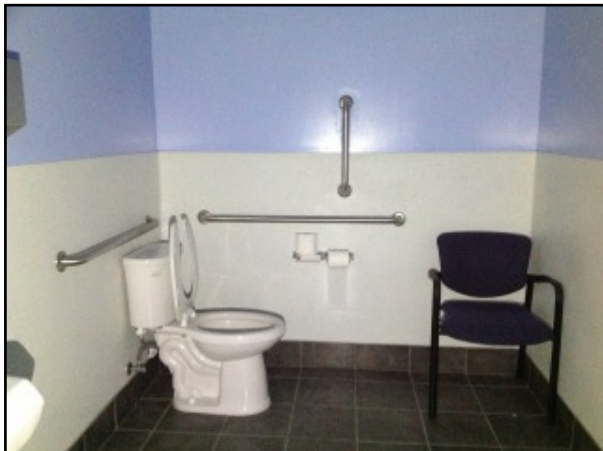
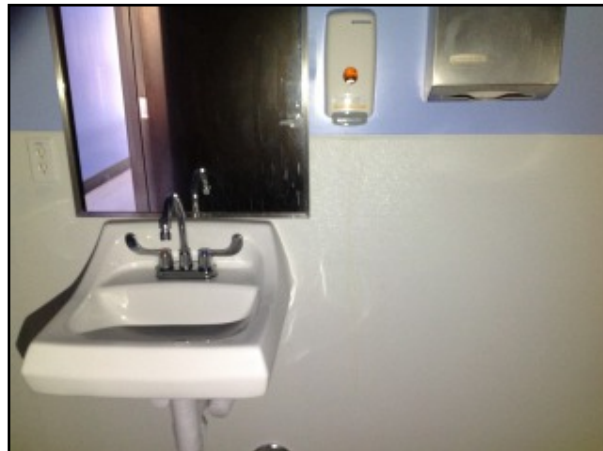
Comment 22:  
RR2.

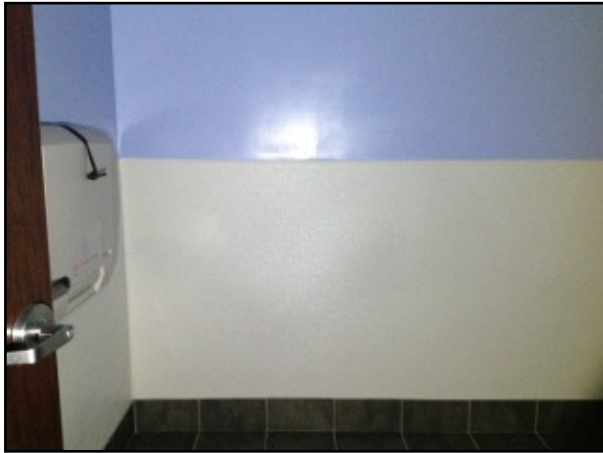
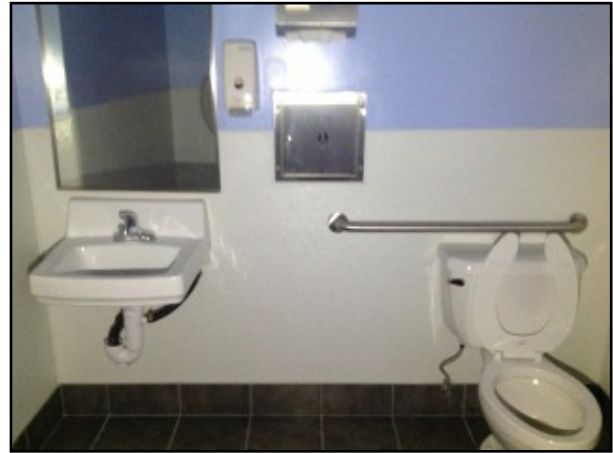
Comment 23:  
RR3.

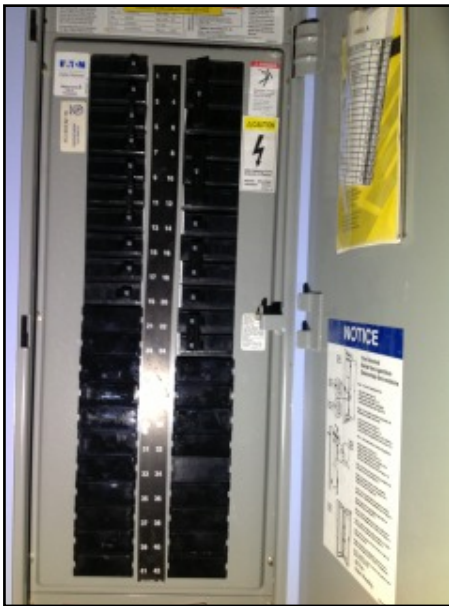
Figure 24-1

Comment 24:  
Main.

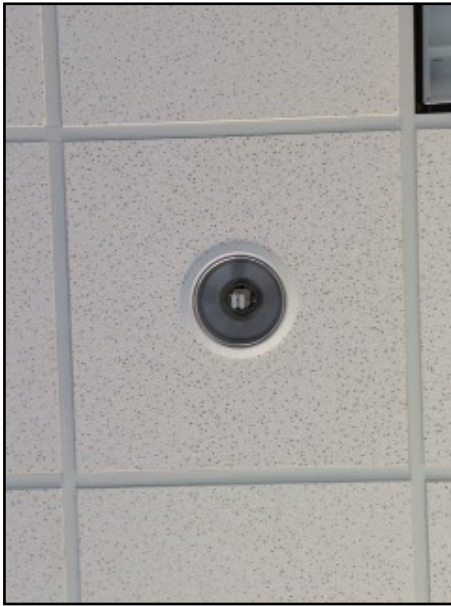
Figure 26-1

Comment 26:  
Can.

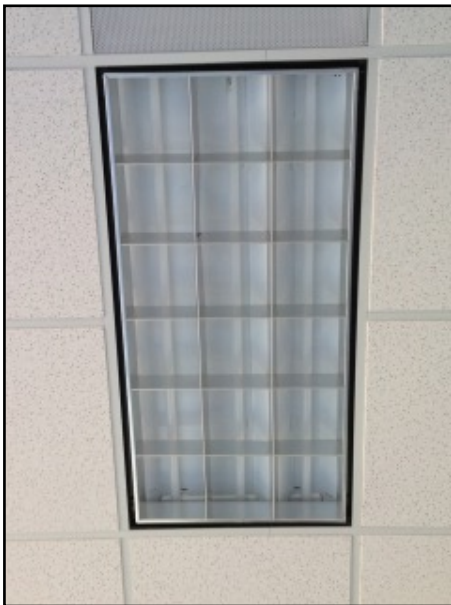
Figure 27-1

Comment 27:  
2x4 3 bulb.

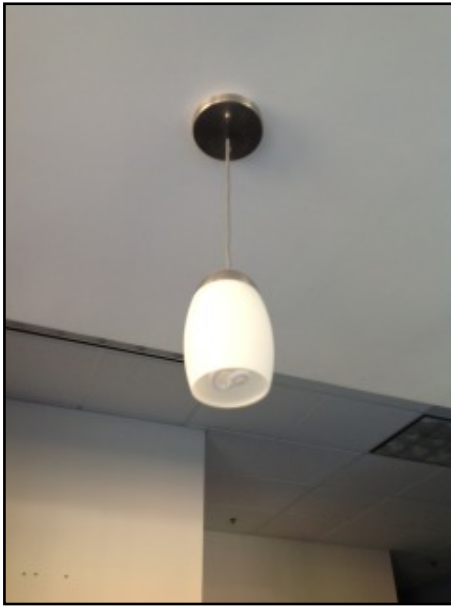
Figure 28-1

Comment 28:  
Pendant.

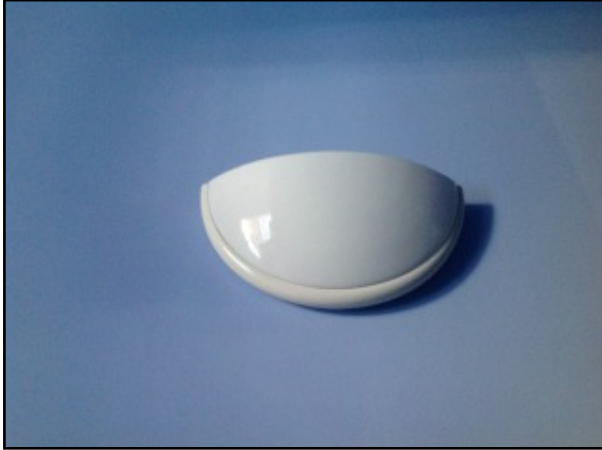
Figure 29-1

Comment 29:  
Wall fixture.

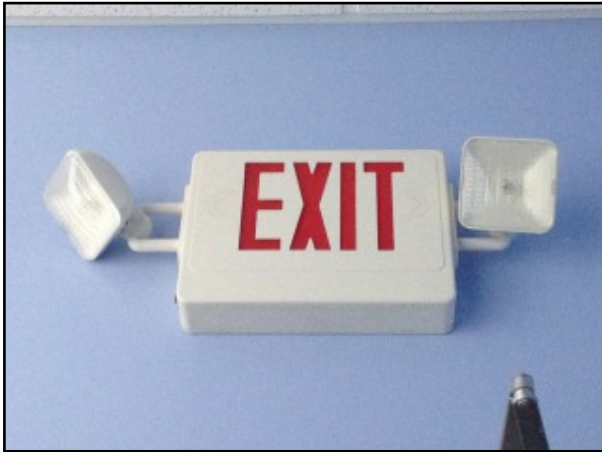
Figure 30-1

Comment 30:  
Exit emergency.

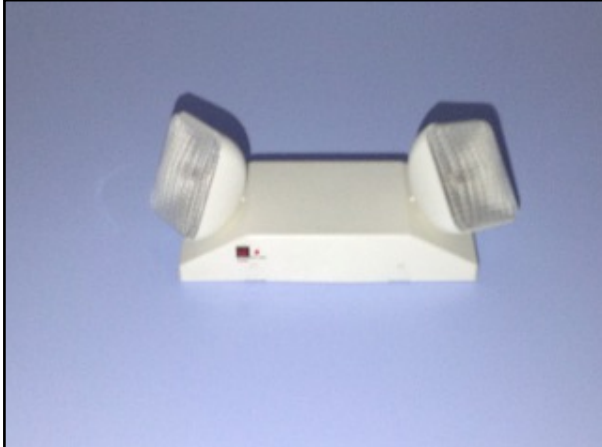
Figure 31-1

Comment 31:  
Emergency.

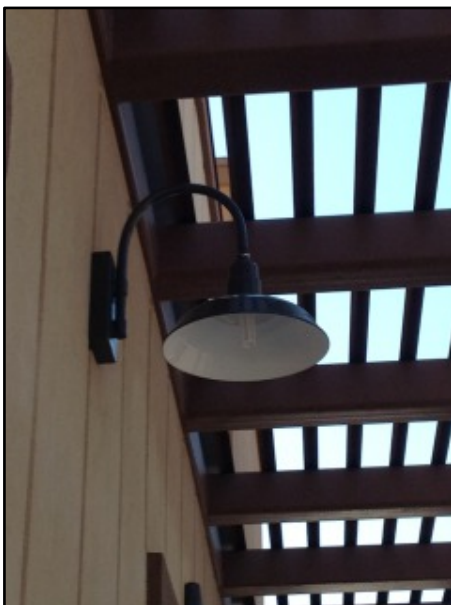
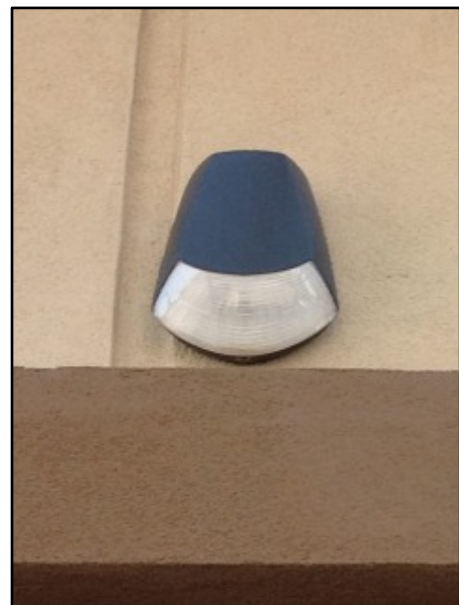
Wall fixture / wall PAC.

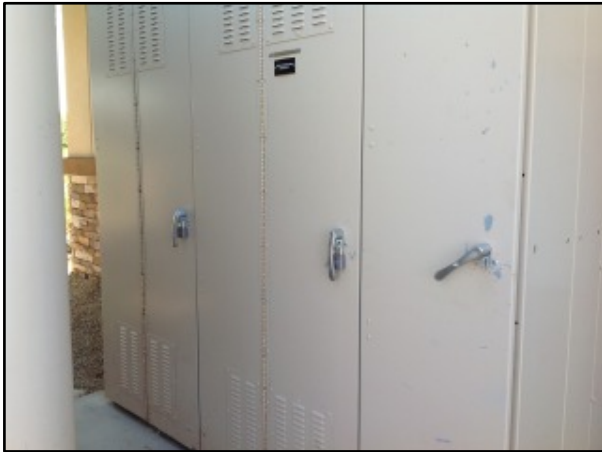
Figure 34-1

Comment 34:  
Meters in cabinet.

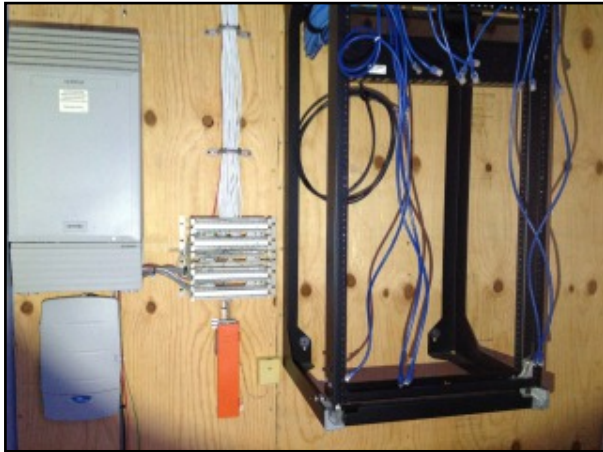
Figure 35-1

Comment 35:  
TBB.

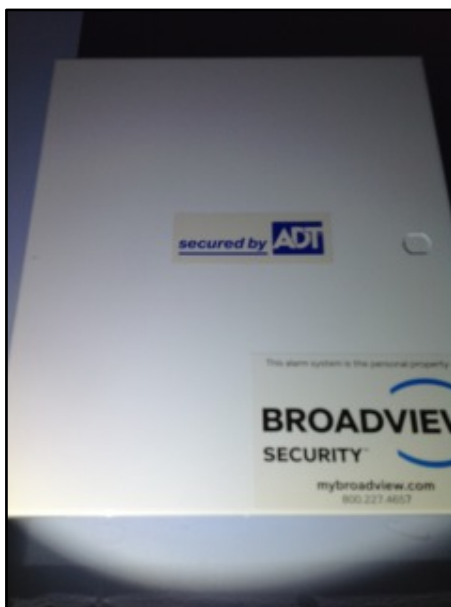
Figure 36-1

Comment 36:  
Panel.

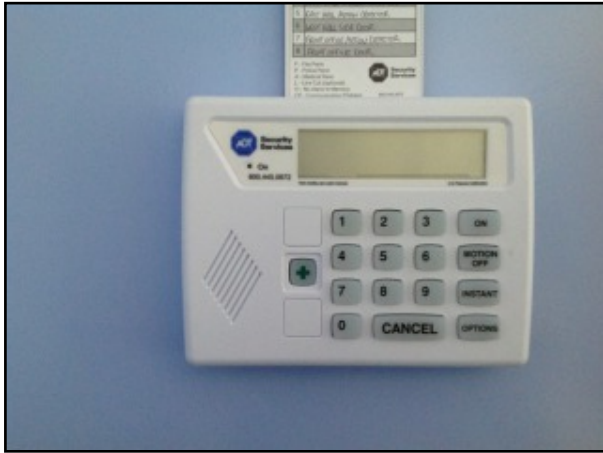
Figure 37-1

### Comment 37: Keypad.

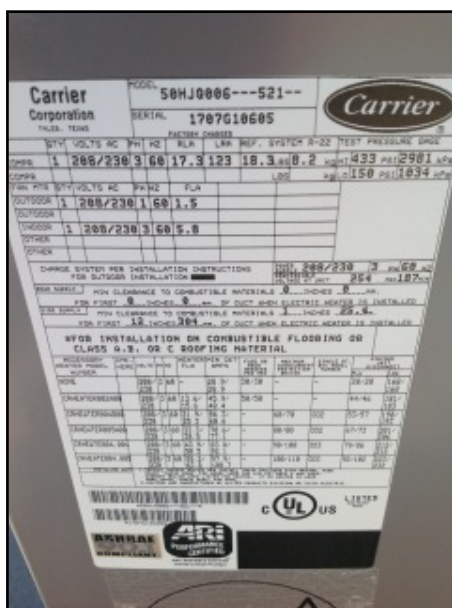
Figure 38-1

Label.

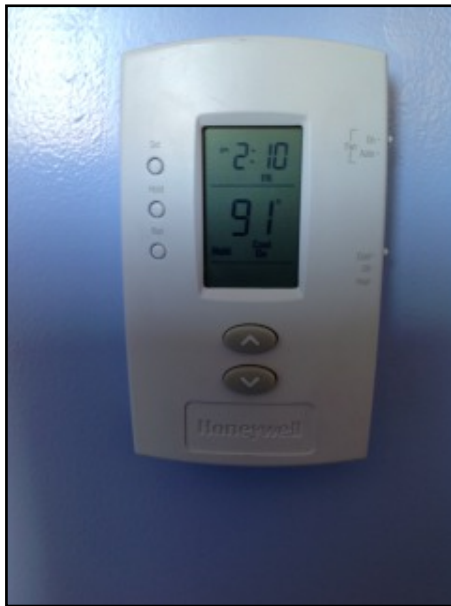
Figure 39-1

Thermostat.

Furnaces over 10 years old should be checked, cleaned and serviced yearly by a licensed contractor.

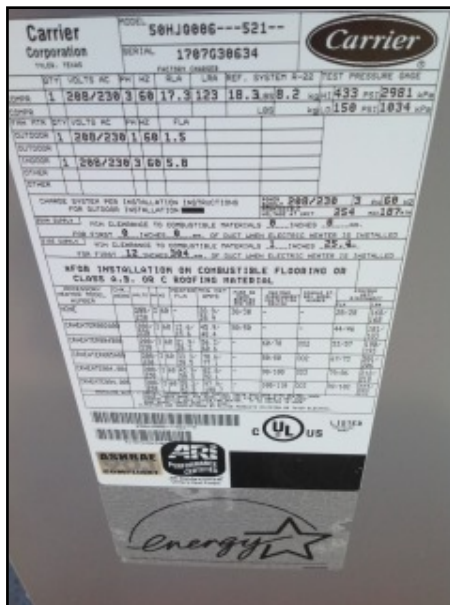
Figure 40-1

Comment 40:  
Label.

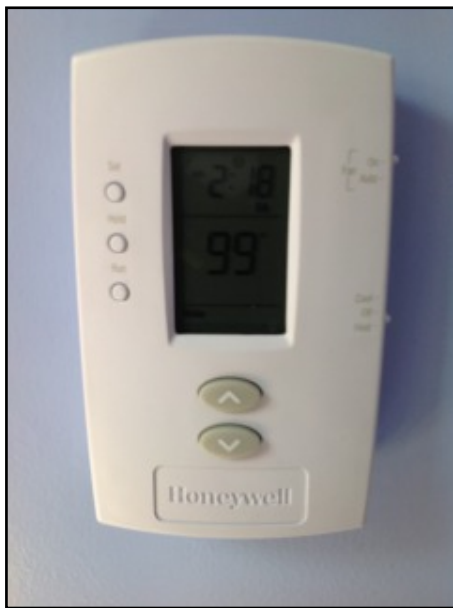
Figure 41-1

Comment 41:  
Thermostat.

Furnaces over 10 years old should be checked, cleaned and serviced yearly by a licensed contractor.

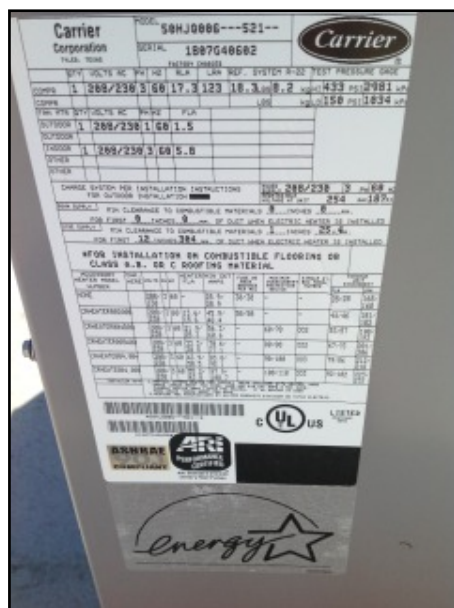
Figure 42-1

Label.

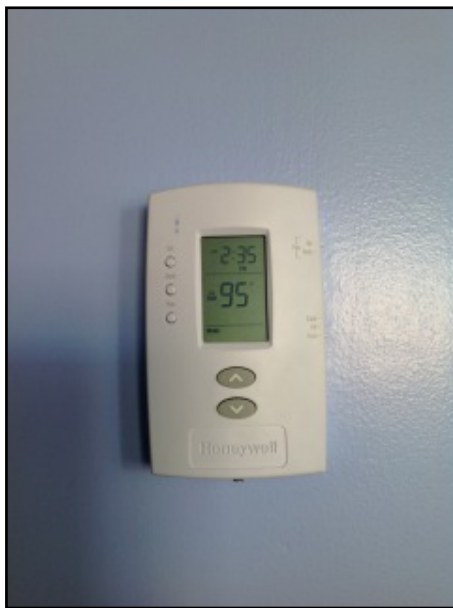
Figure 43-1

Thermostat.

Furnaces over 10 years old should be checked, cleaned and serviced yearly by a licensed contractor.

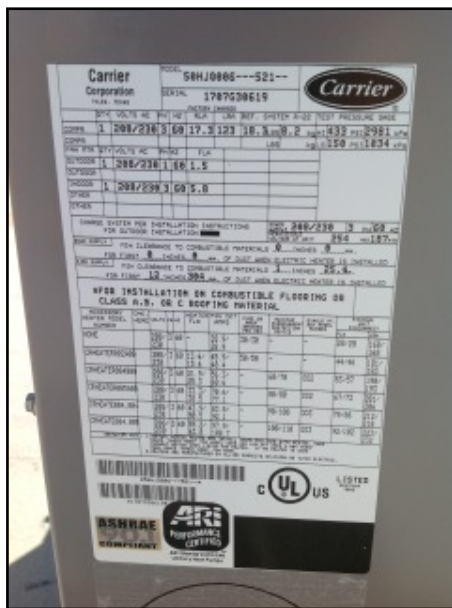
Figure 44-1

Comment 44:  
Label.

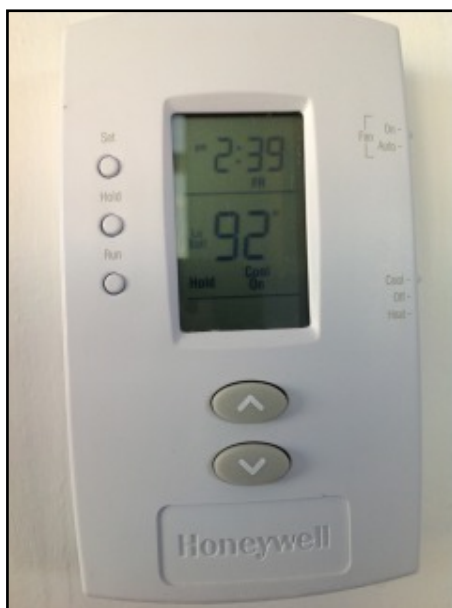
Figure 45-1

Comment 45:  
Thermostat.

Furnaces over 10 years old should be checked, cleaned and serviced yearly by a licensed contractor.

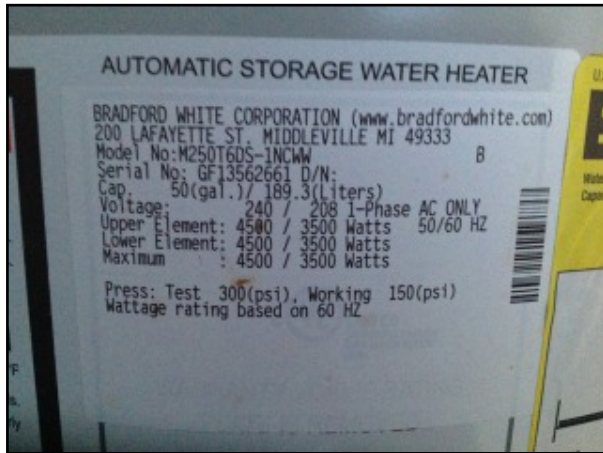
Figure 47-1

Comment 47:  
Label.
